**Subject: Annual Inspection Report  
Fort Deposit Municipal Airport**

## ANNUAL INSPECTION REPORT

FORT DEPOSIT MUNICIPAL AIRPORT

FORT DEPOSIT, ALABAMA

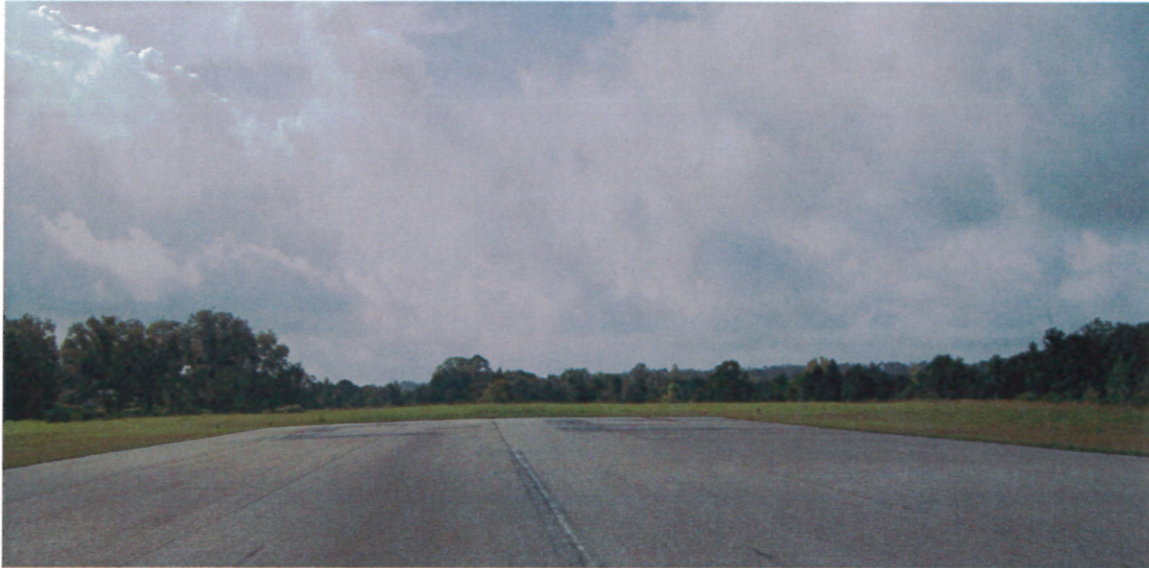
**Photo # 1 - Runway 33 Approach**

- Runway 33: No obstructions (See Photo # 1 and Appendix 2).
- Runway 15: Trees identified as Tree # 8, Tree # 9, and Tree # 10 violate the 20:1 approach/departure path. Also, trees identified as Tree # 11, Tree # 12 and Tree # 13, if allowed to continue growing will become obstructions (See Photo # 2 and Appendix 3).

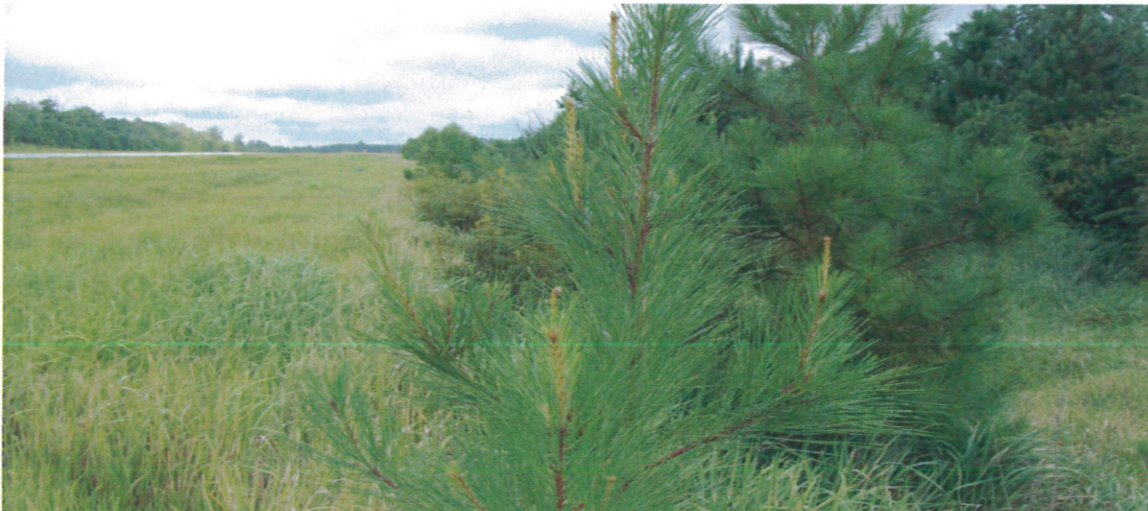
**Photo # 3 – East Side of Runway**

- The primary surface is violated by trees and other vegetation growing within 125 feet from the centerline of the runway. These violations were found on east and west side of runway (See Photo # 3, and # 4). The primary surface also has an area of erosion north east of threshold to runway 15. The erosion is within 80 feet of the extended runway center line (See Photo # 5).

- Young trees, along with other vegetation have been allowed to encroach on the primary surface of both sides of the runway (within 125' of the runway centerline). These obstructions must be cleared and the primary surface maintained in a mowable condition to preclude obstructions from returning. As mentioned in previous reports the eroded area should be evaluated by a qualified engineer and repaired accordingly, as the area of erosion continues to grow.

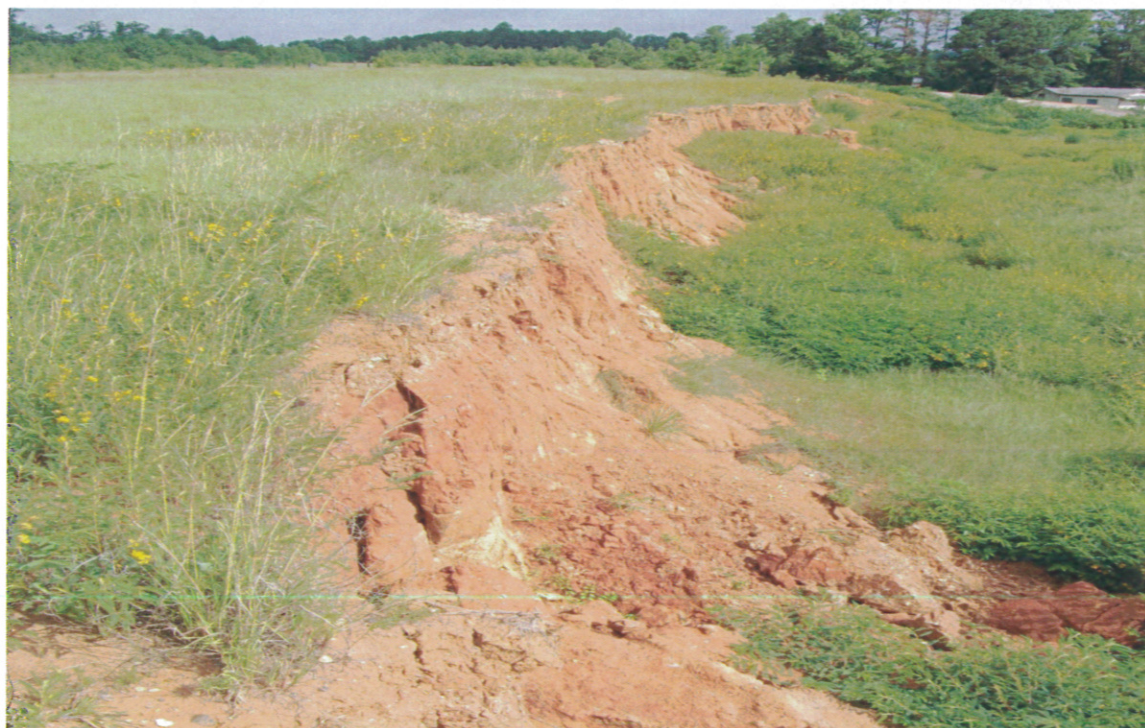
**Photo # 5 – Erosion**

There is also several maintenance items mentioned in the report that are recurring from last year's report without any visible progress being made to correct them. The Aeronautics Bureau is in possession of a grant request to repair the erosion problem on the north east corner of the field, but as of this date has not received the plans and specifications requested in our letter dated February 2, 2010.

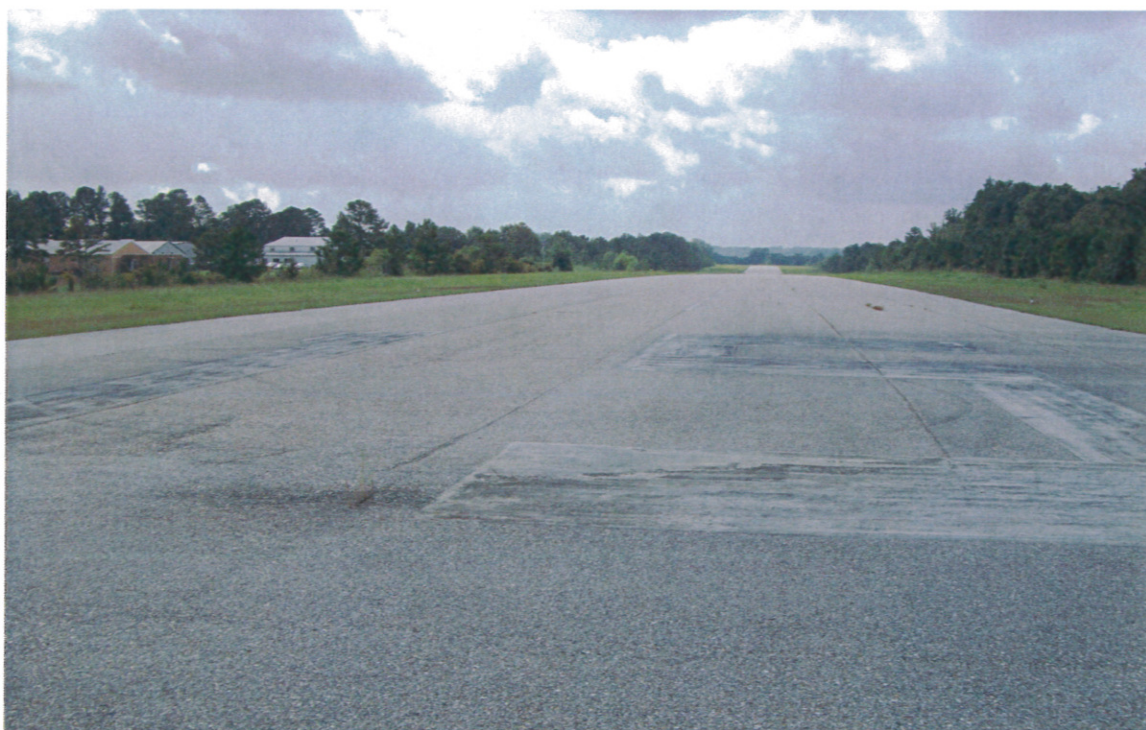
**Photo # 5 – Faded Markings**

- The runway markings are in poor condition (See Photo # 5).

- The markings should be re-marked in accordance with FAA AC 150/5340-1J.

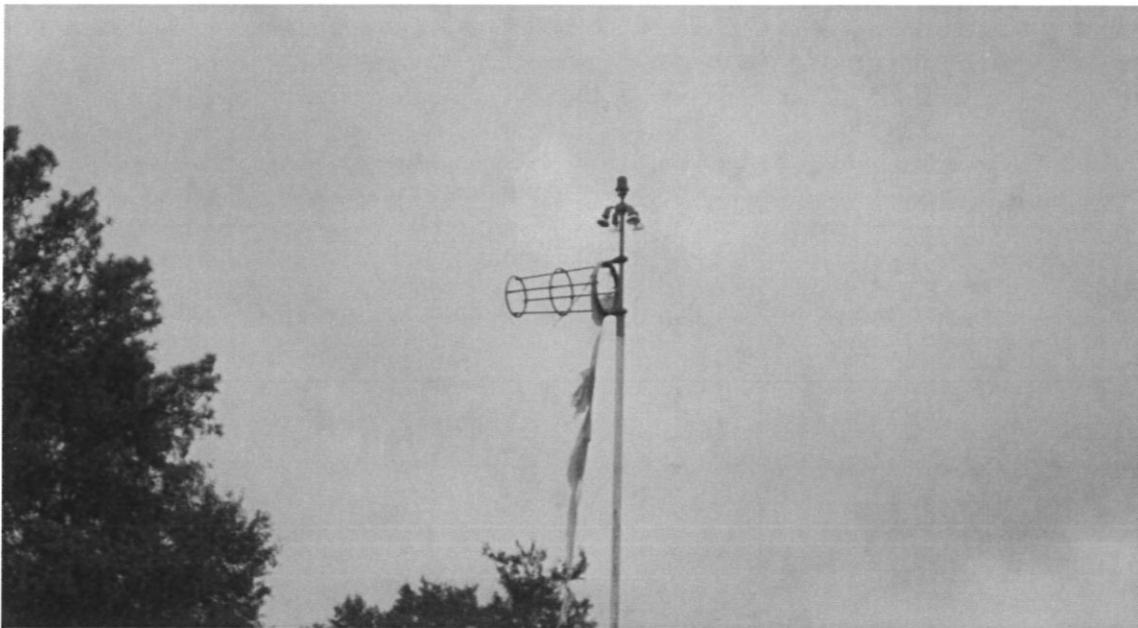
**Photo # 6 – Wind Cone**

- The wind cone fabric was torn to shreds (See Photo # 6).

- Wind cone fabric should be replaced.

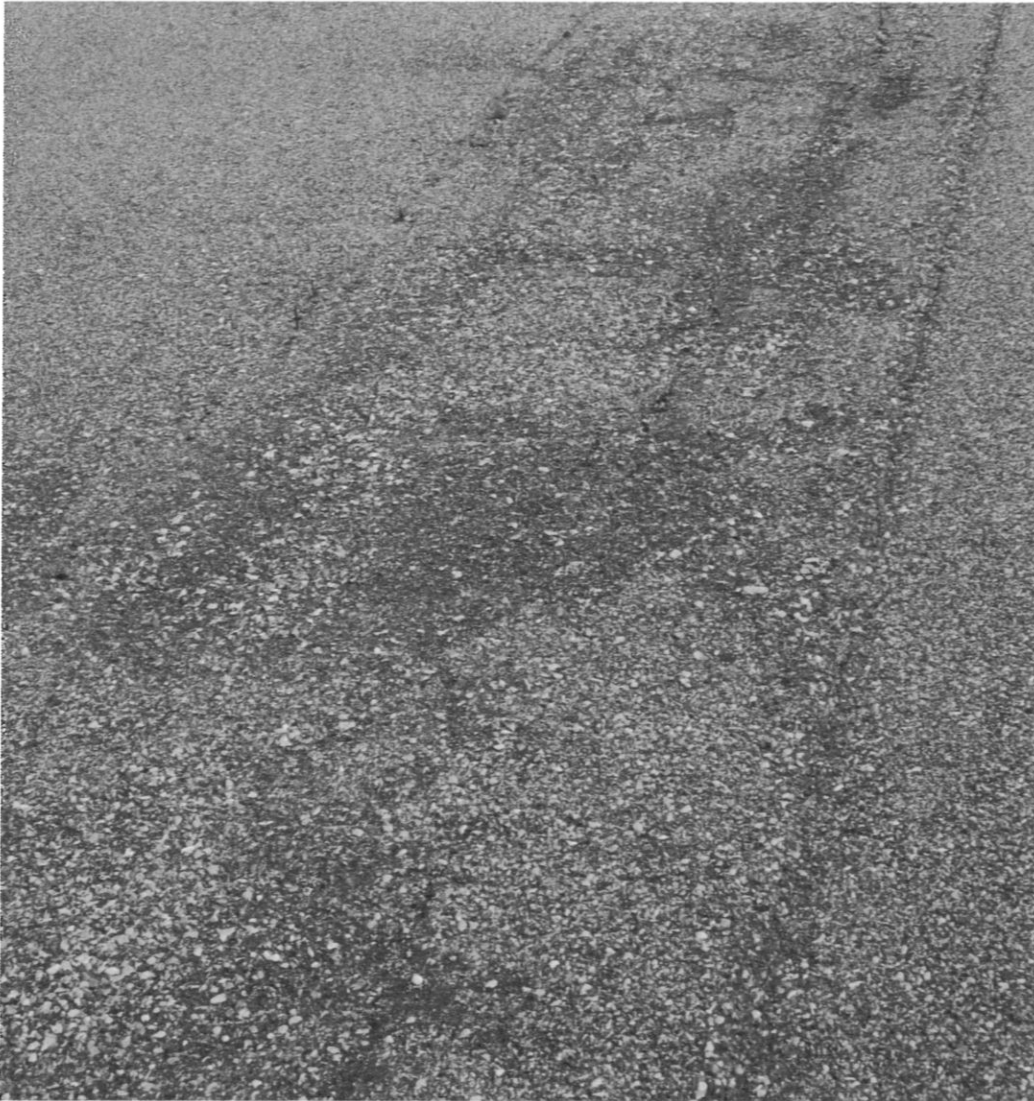
**Photo # 7 – Surface Raveling**

- The airport pavement surfaces are in fair condition. There is evidence of moderate raveling (See Photo # 7), along with paving joint cracks with vegetation growing from the cracks.

- Cracks should be cleaned and sealed and at some point a surface treatment or tin overlay will be required.

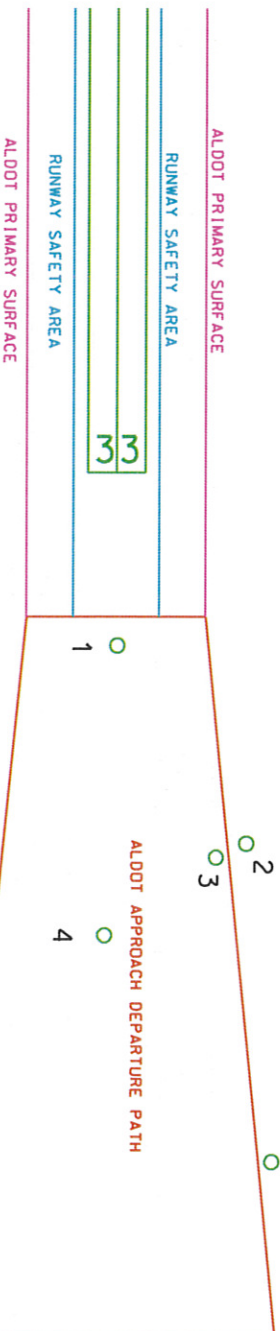
### RUNWAY 33

- \* 1. FENCE POST - 1.85' ABOVE RUNWAY  
240' FROM RUNWAY END  
2' RIGHT OF CENTERLINE  
21:1 OBSTRUCTION CLEARANCE SLOPE
- \* 3. TREE - 15.9' ABOVE RUNWAY  
546' FROM RUNWAY END  
141' RIGHT OF CENTERLINE  
22:1 OBSTRUCTION CLEARANCE SLOPE
- \* 4. TREE - 15.5' ABOVE RUNWAY  
642' FROM RUNWAY END  
15' LEFT OF CENTERLINE  
28:1 OBSTRUCTION CLEARANCE SLOPE

\* NOT AN ALDOT OBSTRUCTION
